## **OPTIMIZATION OF HYDRO POWER PLANTS PERFORMANCE IMPORTANCE OF REHABILITATION AND MAINTENANCE IN PARTICULAR FOR THE RUNNER PROFILES**

### ***ABSTRACT***

Hydraulic efficiency plays a relevant role on the performance of Hydro Power Plants (HPP) and constitutes one of the main elements for selecting the most appropriated interventions both of ordinary and extraordinary maintenance as well as for the choice of the consequent amount of investment.

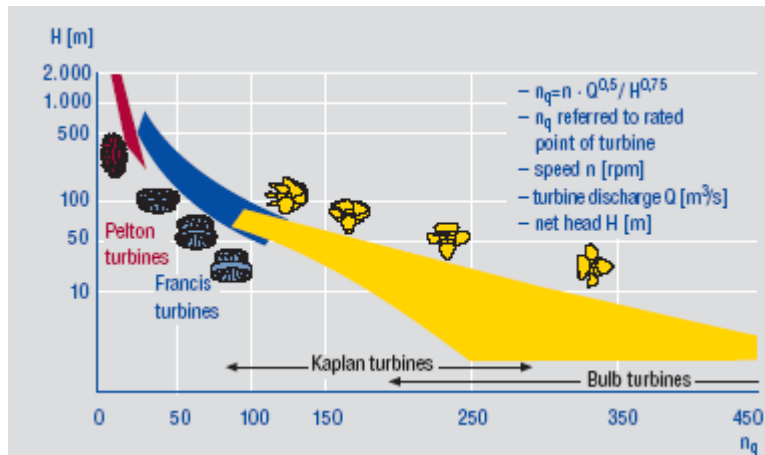
Fig.1 Application range of hydraulic turbines H- nq

According to the different combinations of the couple of values head and discharge, available for the same turbine power, there are different and well known arrangements, passing from Pelton turbines for high heads, to Francis turbines for medium heads, till Kaplan turbines in their spiral case or ducted arrangement (bulb), for lowest heads (See Fig.1).

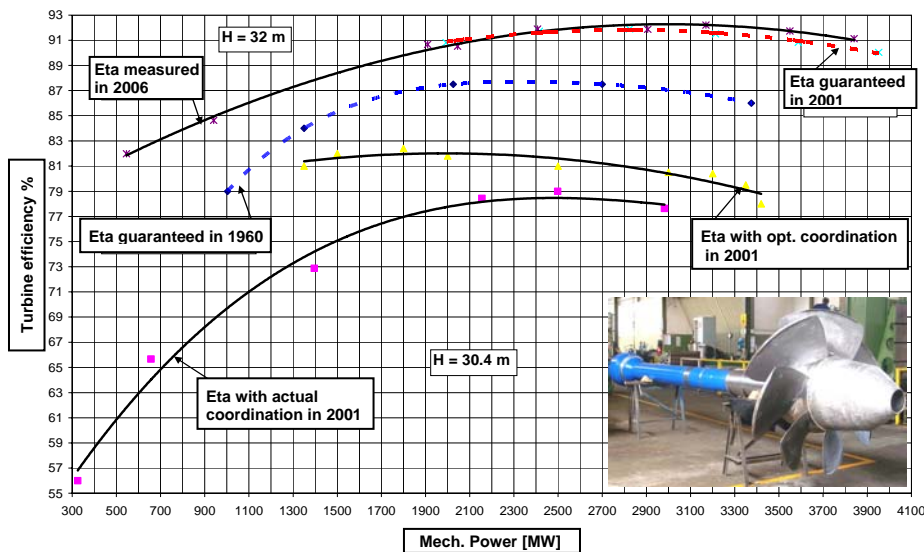
An example of performance improvement thanks to partial renewal of a vertical Kaplan group, with new runner and distributor, while the embedded parts are left unchanged, is reported in Fig .6.

The measured performances, before and after the intervention, are here compared.

Fig 6 Partial renewal of Kaplan group

As it is shown in the above said examples, the level of performance improvement, that can be reached by a partial renewal, can rise up to 5%, depending on the obsolete machine conditions.

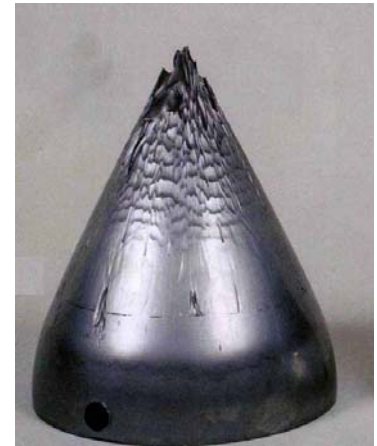
Fig. 7 – Eroded needle

As known, the purpose of needle and nozzle is to concentrate the jet in a cylindrical and uniform shape in order to maximize the energy transformation in the runner. Wear on needle and nozzle causes a jet deformation which results in a decay of efficiency and possibly an appearance of cavitation.

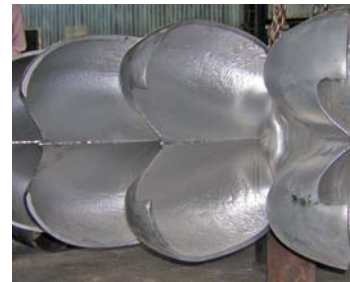
Fig. 10 – Eroded buckets

The losses due to increased roughness of active bucket surfaces are higher and therefore worsening energy transformation.

- increased friction losses from waviness of the worn surface and
- an offset from the optimum hydraulic profile.

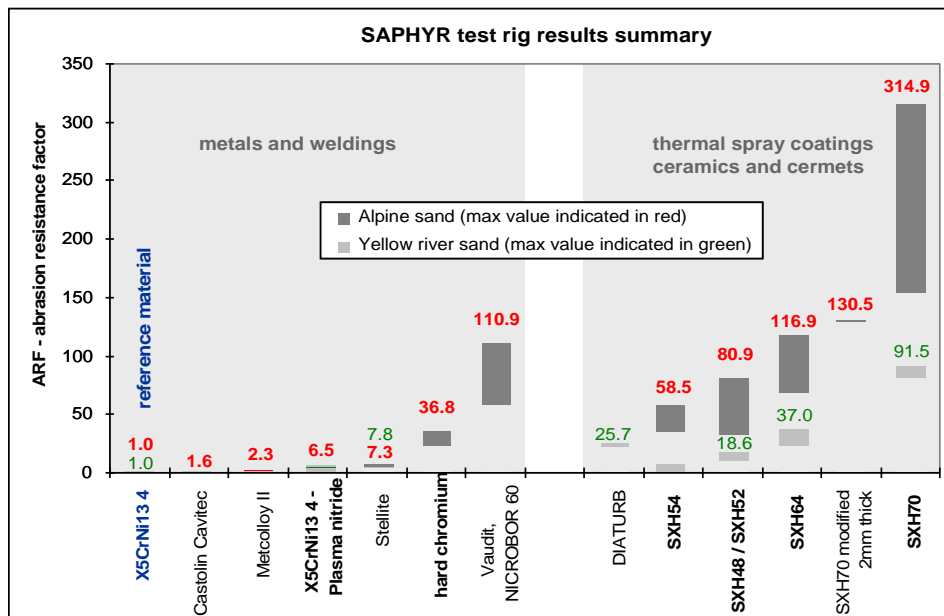
In the following table a comparison of the abrasion resistance for some commercial materials is reported.

Fig 18 Comparative abrasion resistance for some commercial materials

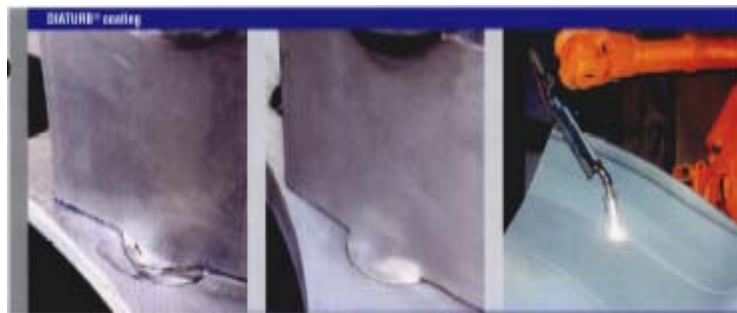
We draw the attention to the fact that, for the quality of the coating and therefore for its efficacy and time duration, it is very important to respect the constant parameters of application, e.g. thickness, angle and velocity of application.

Fig 20 Coating on Francis components
